The Columbia Accident Investigation & The NASA Glenn Ballistic Impact Laboratory
Contributions Supporting NASA's Return to Flight

Matthew E. Melis, NASA Glenn Research Center, Cleveland, Ohio

On February 1, 2003, the Space Shuttle Columbia broke apart during reentry, resulting in loss of the vehicle and its seven crewmembers. For the next several months, an extensive investigation of the accident ensued involving a nationwide team of experts from NASA, industry, and academia, spanning dozens of technical disciplines. The Columbia Accident Investigation Board (CAIB), a group of experts assembled to conduct an investigation independent of NASA, concluded in August, 2003 that the most likely cause of the loss of Columbia and its crew was a breach in the left wing leading edge Reinforced Carbon-Carbon (RCC) thermal protection system initiated by the impact of thermal insulating foam that had separated from the orbiters external fuel tank 81 seconds into the mission's launch. During reentry, this breach allowed superheated air to penetrate behind the leading edge and erode the aluminum structure of left wing, which ultimately led to the breakup of the orbiter. The findings of the CAIB

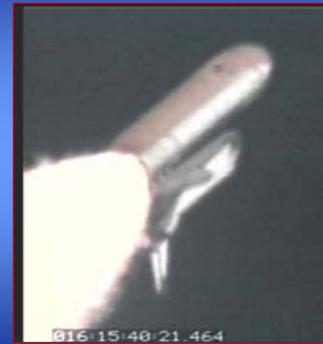
On January 16 2003, Columbia's leading edge was impacted by a piece of foam suspected to have separated from the external tank bipod ramp at 81 seconds into its launch.

Columbia was traveling at Mach 2.46, at an altitude of 65,860 feet. The foam was calculated to have hit the orbiter at 700 – 800 feet per second

Insulating Foam Separates from Bipod Ramp and Impacts Left Wing of Columbia

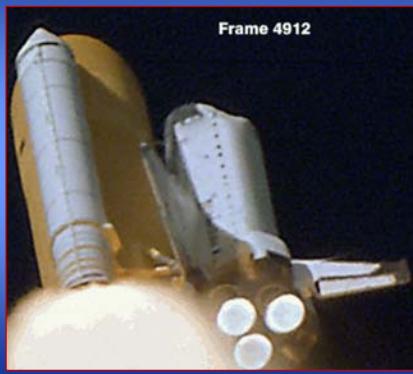
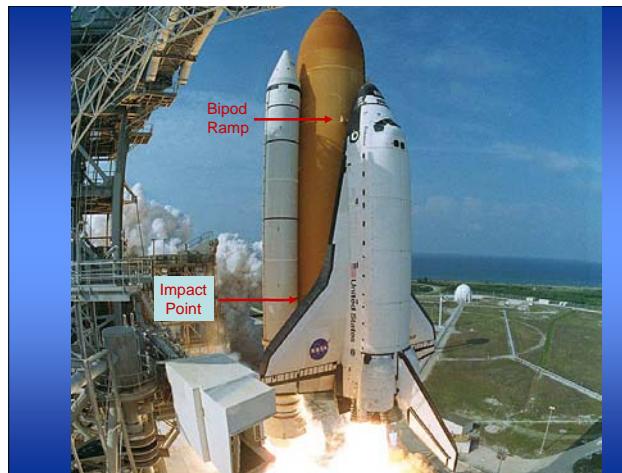
Insulating Foam Separates from Bipod Ramp and Impacts Left Wing of Columbia

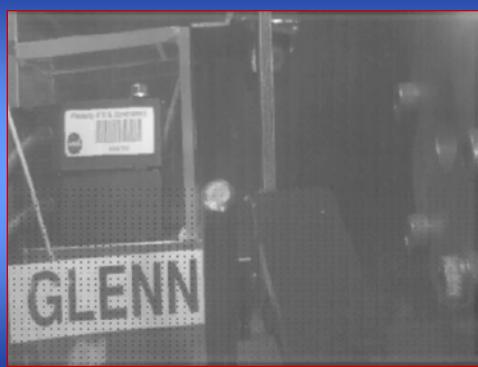
RCC Coupon Shows No Damage After 397 ft/sec Foam Impact

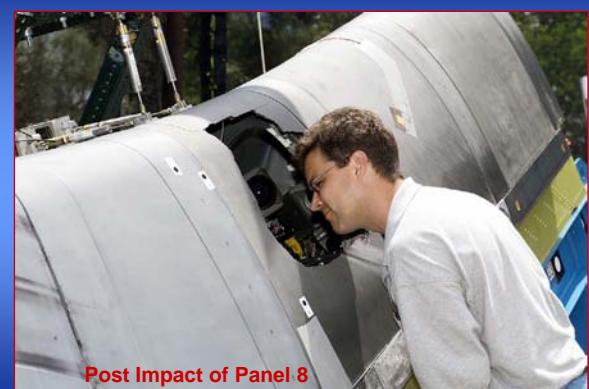
Post Impact of Panel 8

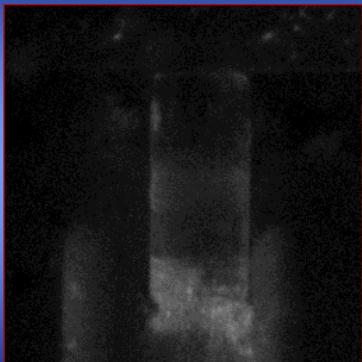
Hadland Camera Captures Fracture Wave Propagation

700 ft per second ice impact 280,000 frames per second

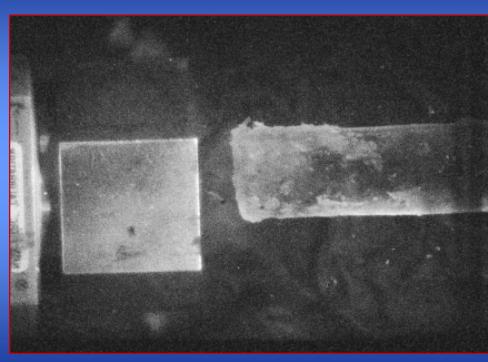
Cordin Camera Captures Fracture Wave Propagation

600 ft per second ice impact at 480,000 frames per second

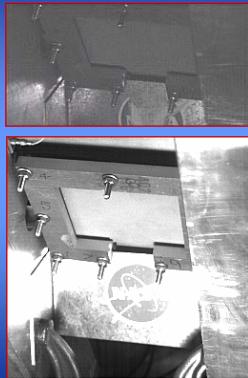
Post Impact RCC Panels Flown on STS-114

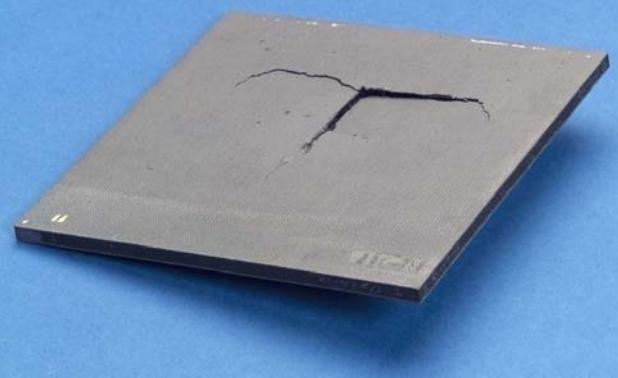
Post Impact RCC Panels Flown on STS-114

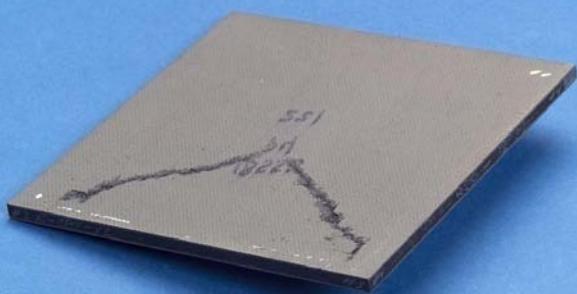
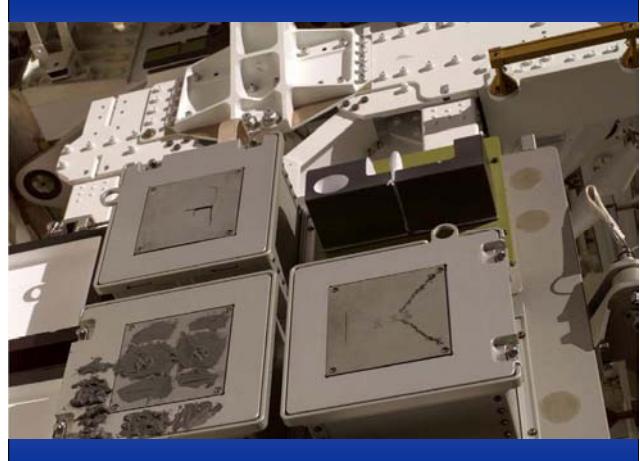
Damaged RCC Panels Scanned with LDRI and LCS

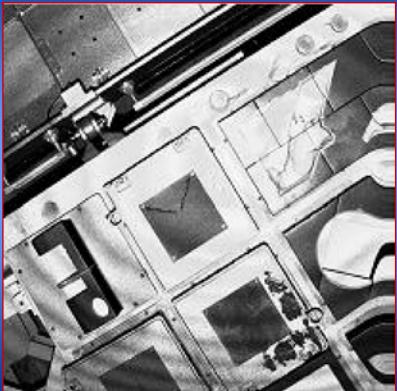
Damaged RCC Panels Scanned with LDRI and LCS
